MANHOLE EXPLOSIONS have occurred in many cities and are concerning to citizens. This article cites some manhole explosion events, shows the measures taken so far by authorities in Rio de Janeiro, analyzes some hypotheses for the root causes, and provides some suggestions to solve this dangerous problem.

EXPLOSION RISK IN UNDERGROUND NETWORKS

Measures for preventing manhole explosion events

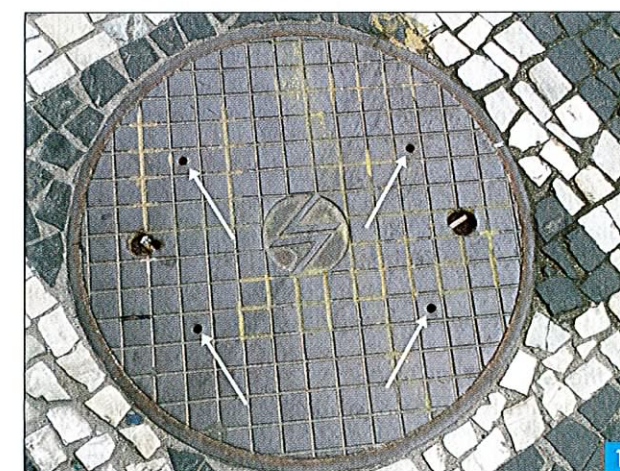
These holes cut into manhole covers are intended to aid in the release of gas buildup.

Another questionable measure was the drilling of holes on the manhole covers to ensure the release of accumulated gas inside the underground system. However, this is not considered efficient because the gas dissipation inside the underground ducts is not smooth, and gas accumulation in some points can occur. Figure 1 shows such holes (four) completed in 6,478 manhole covers.

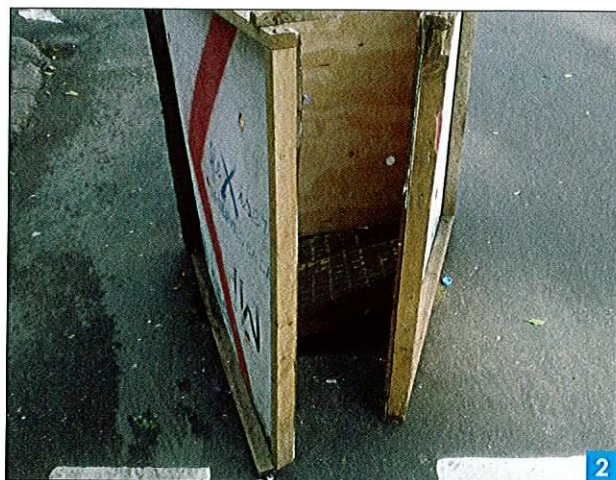
An isolated and signaled manhole with a considered high flammable gas concentration, waiting for repairs.

Figure 2 shows an isolated manhole, with the cover partially open, waiting for repairs. Once the first measuring values were issued, newspapers published headlines such as "A Manhole with 80–100% Explosion Risk Was Found," based on the gas concentration indicated on the explosimeter display. This is a misconception because when the explosimeter indicates "80," it means that the gas that passed through the sensor has a concentration corresponding to 80% of the calibration gas LEL, e.g., methane. Therefore, if the real gas in the manhole was methane, there was not an explosive atmosphere since its LEL was not achieved.

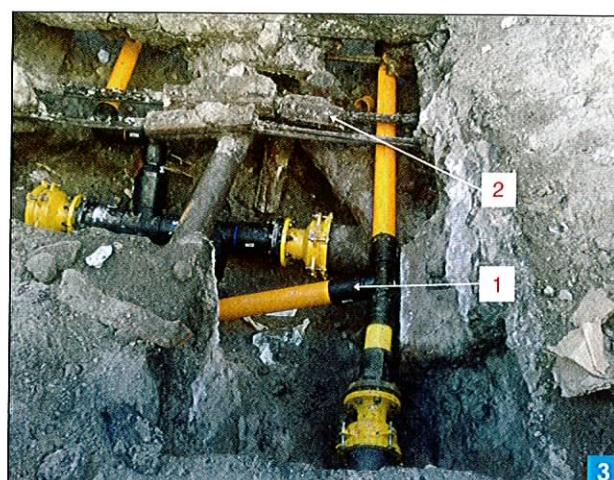
An excavation of the damaged terracotta ducts of the street lighting circuits: 1) new polyethylene gas piping and 2) damaged terracotta ducts exposing the street lighting cables.

Figure 3 shows terracotta ducts with wires inside that were damaged after an excavation made by the gas utility company when replacing the cast iron pipes with polyethylene ones (yellow and black piping). Until now, no manhole explosions had occurred due to the excavations required for repairing services by other companies.
